# ASSET MANAGEMENT PLAN

PHASE II

CORPORATION OF THE  
TOWNSHIP OF  
TERRACE BAY

JUNE 2014

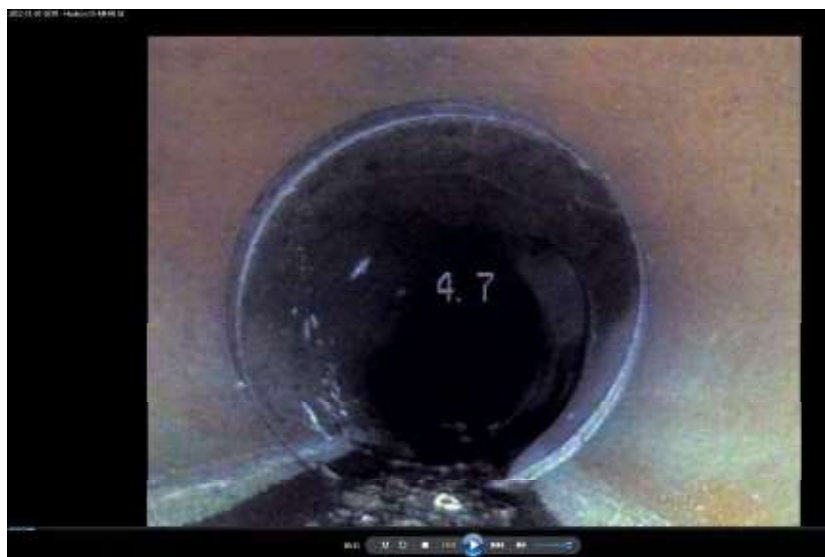
MH76 SE

Cracking (Top)

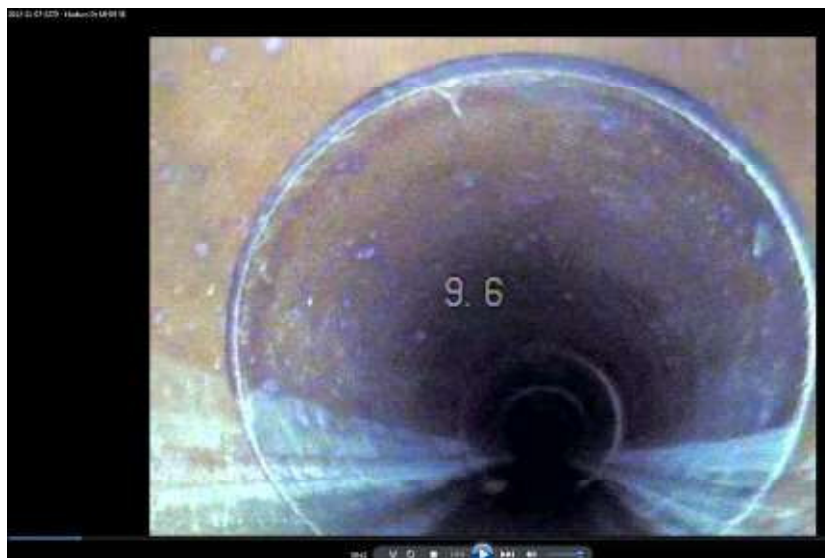
Root

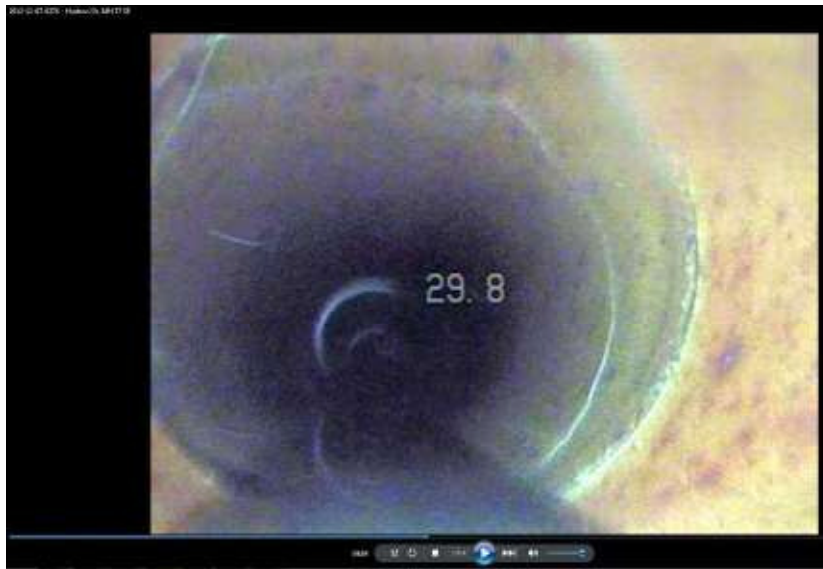
Hudson  
MH78 NW

Cracking

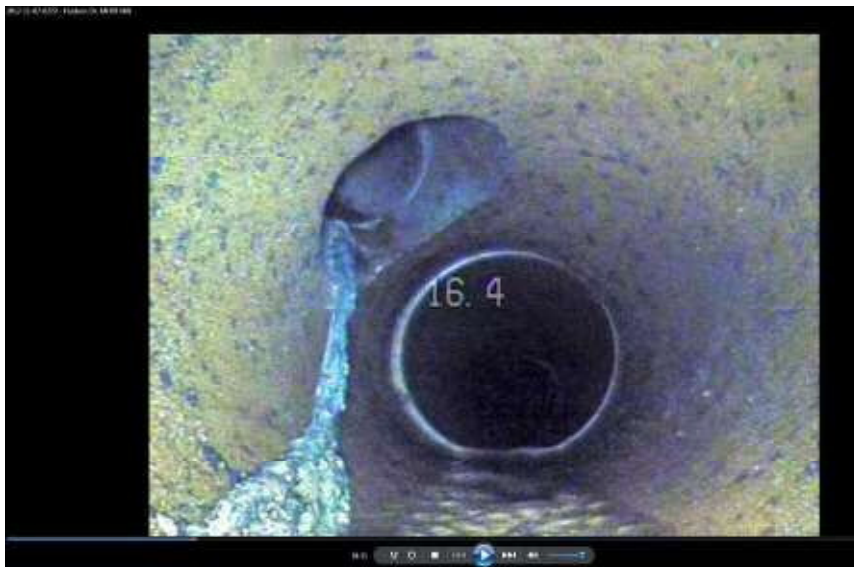
Raddison  
120E

Debris

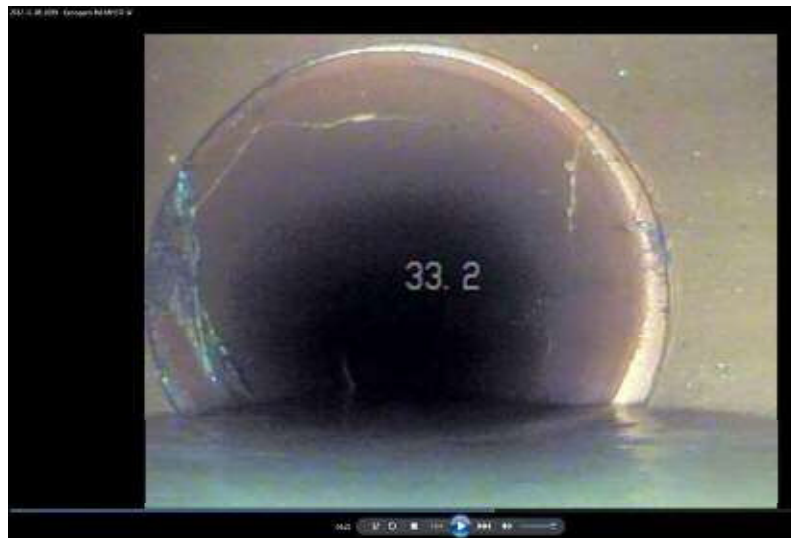
Superior  
MH172-183

Cracking

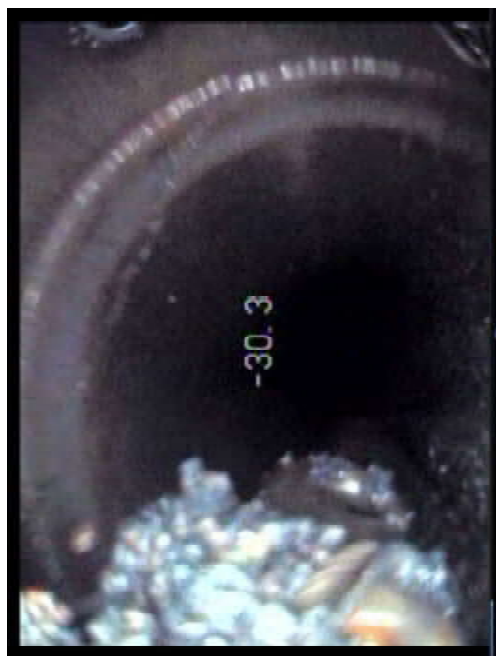
Crack

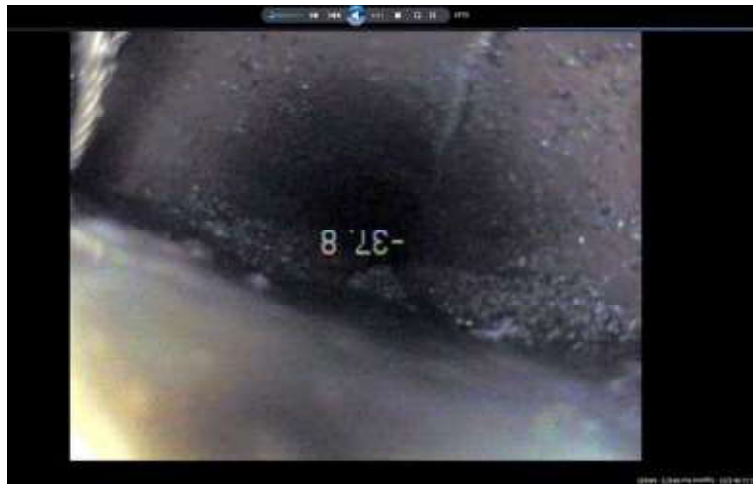
Crack

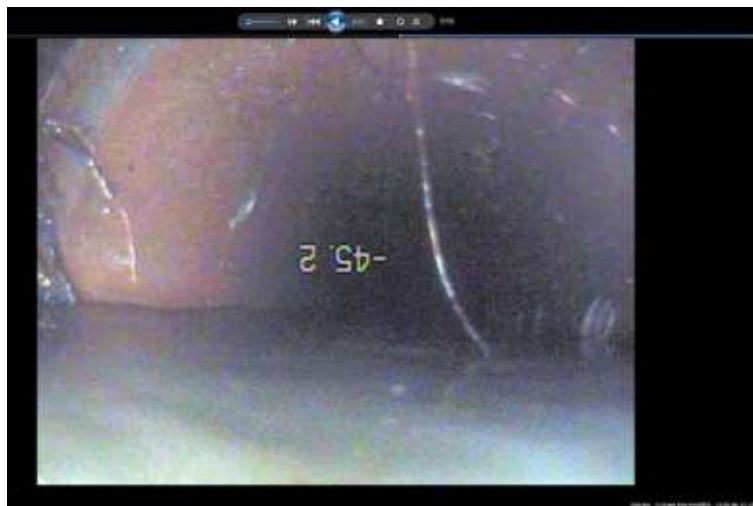
Roots

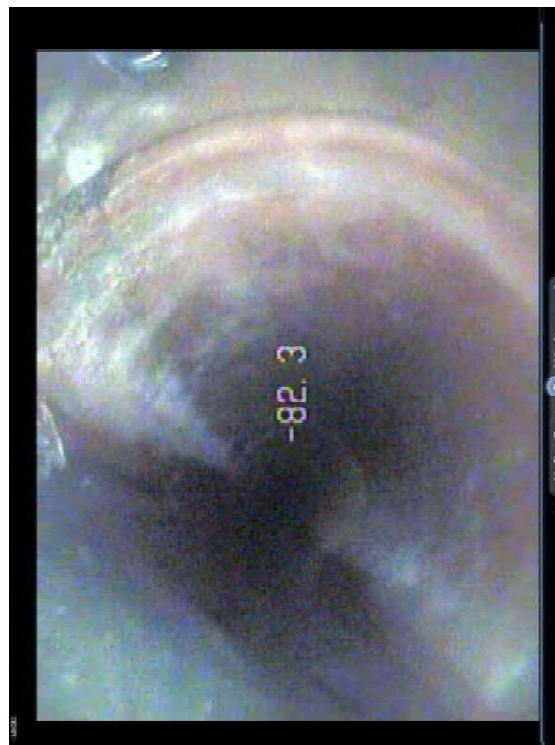
Water Infiltration
