# ASSET MANAGEMENT PLAN

PHASE II

CORPORATION OF THE  
TOWNSHIP OF  
TERRACE BAY

JUNE 2014

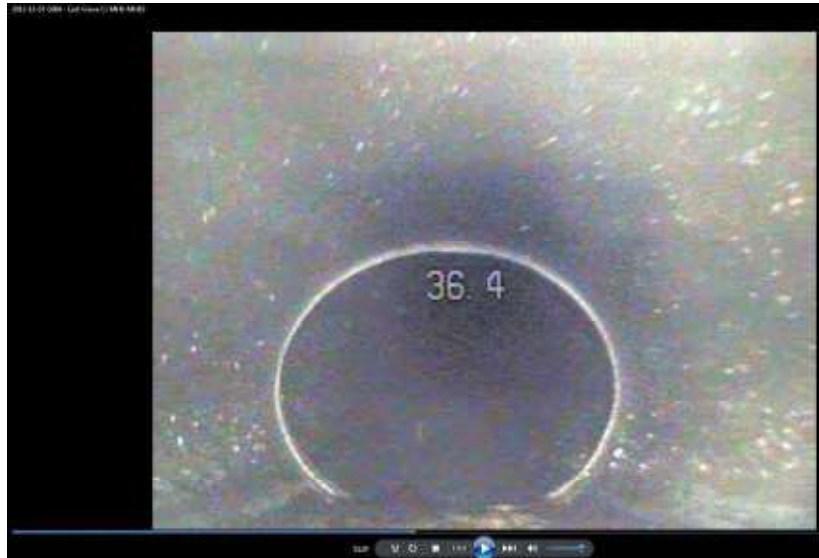
East Grove

Pipe Deformation

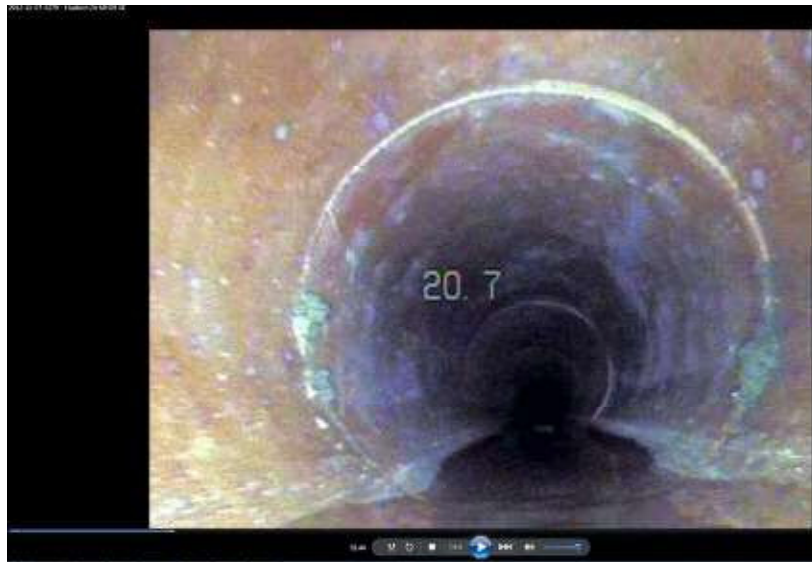
Root

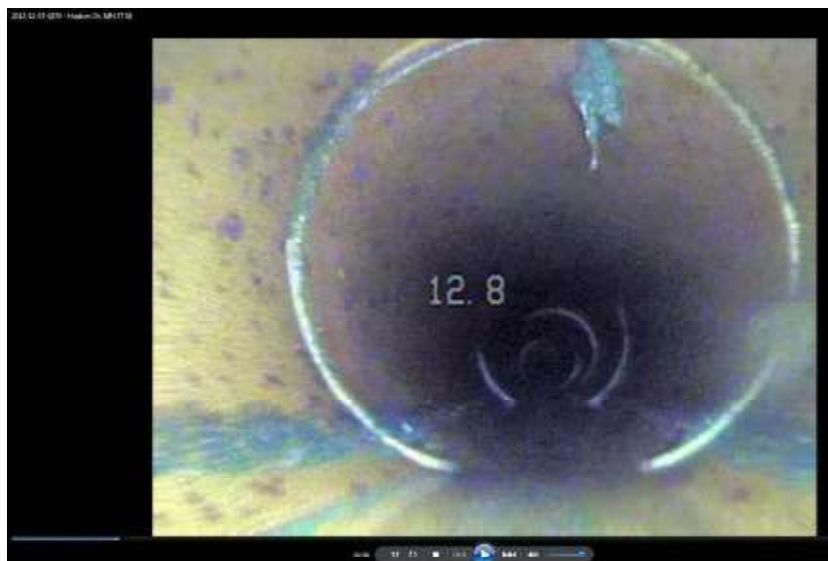
Hudson  
MH77SE

Solids Coming  
Through Joint

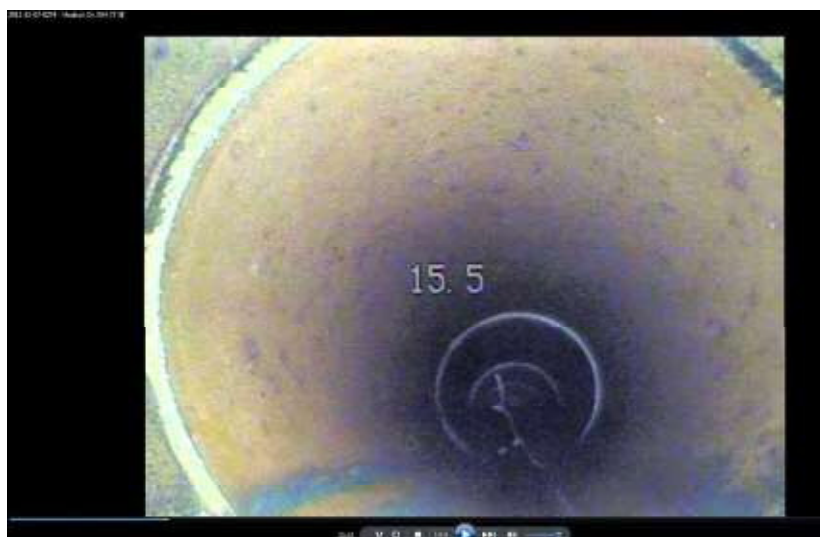
Solids Coming  
Through Joint

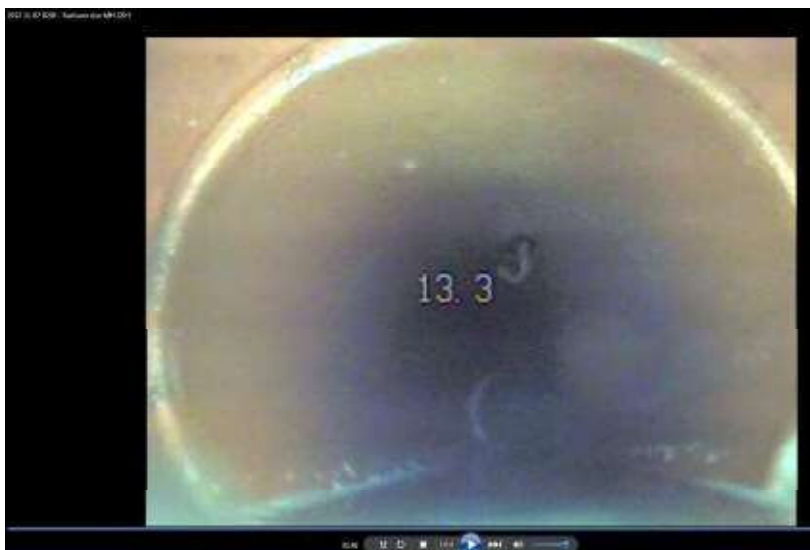
Raddison  
120E

Debris

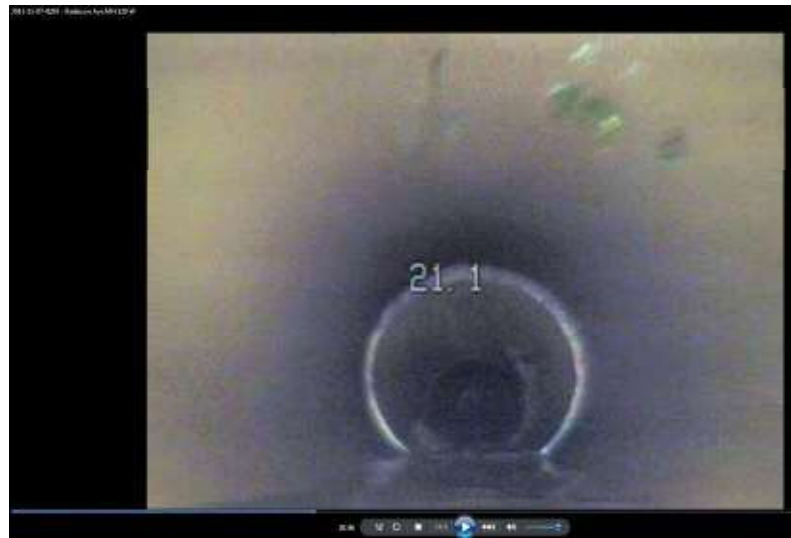
Raddison  
MH120W

Penetration

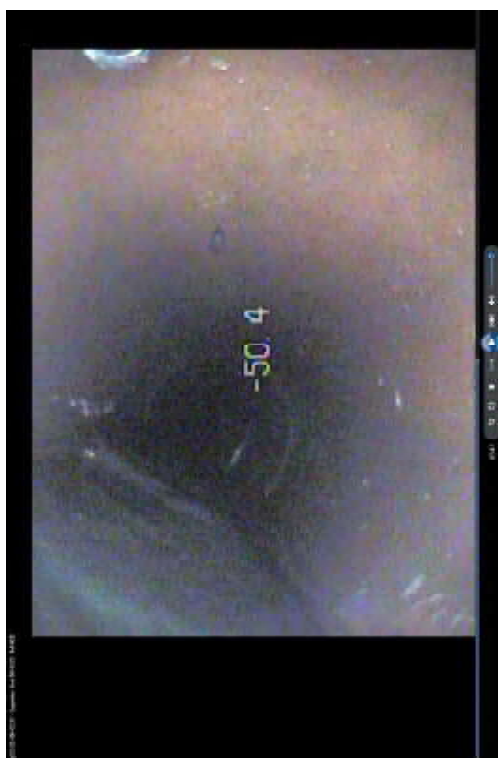
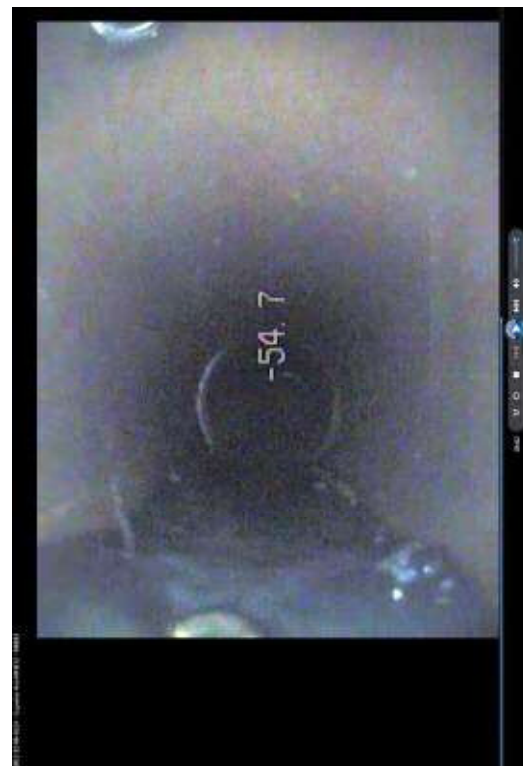
Roots

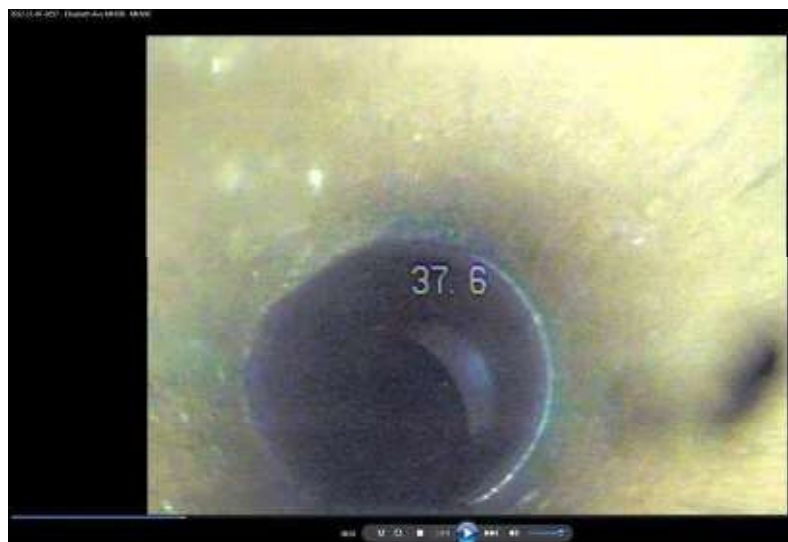
MH191-192

Pipe Deformation

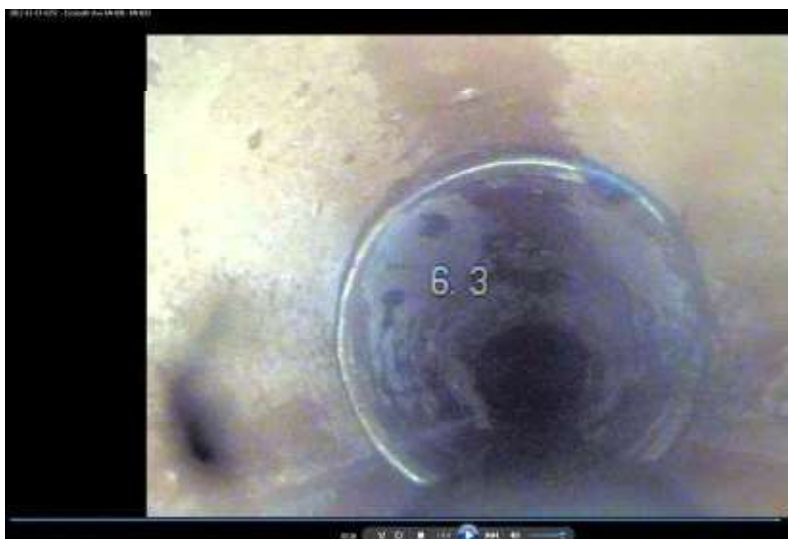
Solid Coming  
Through Joint

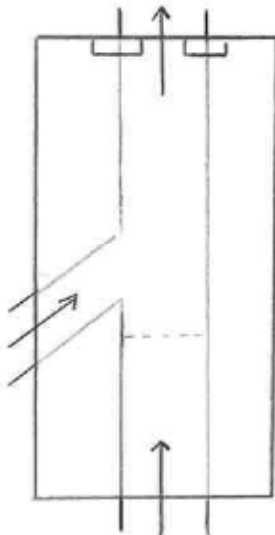
Picture #'s 173-176
Video Recorded # 4
**Plan View**

Visual Infiltration: (Y) N

- ☐ Approx Dia. of Stream: \_\_\_\_\_
- ☐ Water flows freely but most runs down wall
- ☐ Water flows from leak in a bubbling manner and runs down wall
- ☒ Water flows from leak and runs down wall (chimney)

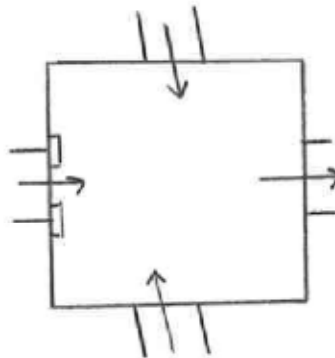
Visual Infiltration: (Y) N

- ☐ Approx Dia. of Stream: \_\_\_\_\_
- ☐ Water flows freely but most runs down wall
- ☐ Water flows from leak in a bubbling manner and runs down wall
- ☒ Water flows from leak and runs down wall

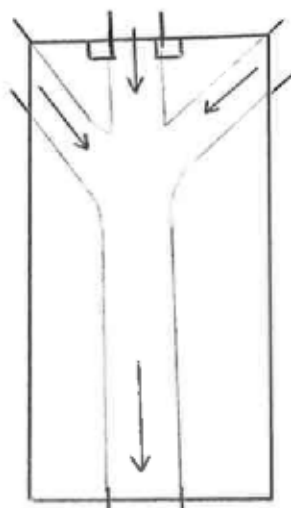
Visual Infiltration: (Y) N

- ☐ Approx Dia. of Stream: \_\_\_\_\_
- ☐ Water flows freely but most runs down wall
- ☐ Water flows from leak in a bubbling manner and runs down wall
- ☒ Water flows from leak and runs down wall

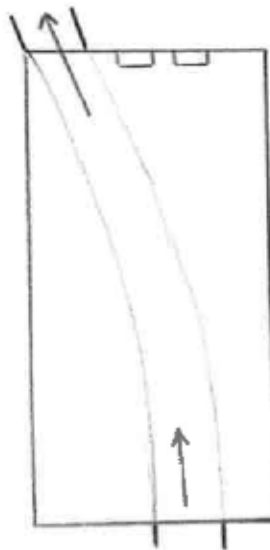
Picture #'s 199-203
**Plan View**

- ☐ Approx Dia. of Stream: \_\_\_\_\_
- ☐ Water flows freely but most runs down wall
- ☐ Water flows from leak in a bubbling manner and runs down wall
- ☒ Water flows from leak and runs down wall (Chimney)

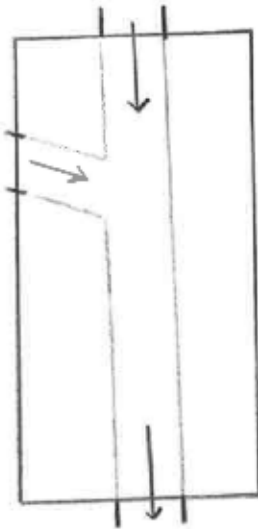
Visual Infiltration: (Y) N

- ☐ Approx Dia. of Stream: \_\_\_\_\_
- ☐ Water flows freely but most runs down wall
- ☐ Water flows from leak in a bubbling manner and runs down wall
- ☒ Water flows from leak and runs down wall (whining)

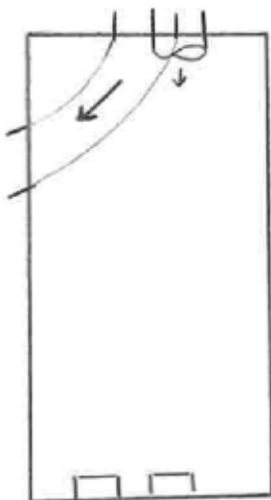
Visual Infiltration: (Y) N

- ☐ Approx Dia. of Stream: \_\_\_\_\_
- ☐ Water flows freely but most runs down wall
- ☐ Water flows from leak in a bubbling manner and runs down wall
- ☒ Water flows from leak and runs down wall

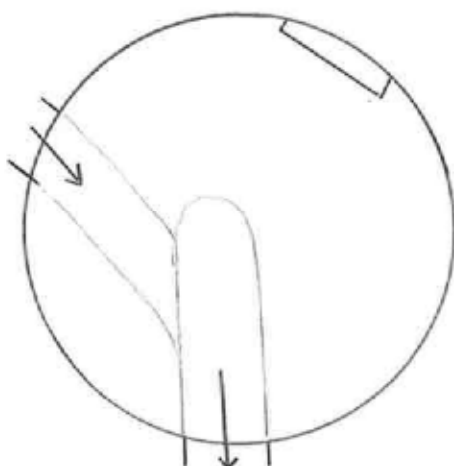
Visual Infiltration: (Y) N

- ☐ Approx Dia. of Stream: \_\_\_\_\_
- ☐ Water flows freely but most runs down wall
- ☐ Water flows from leak in a bubbling manner and runs down wall
- ☒ Water flows from leak and runs down wall

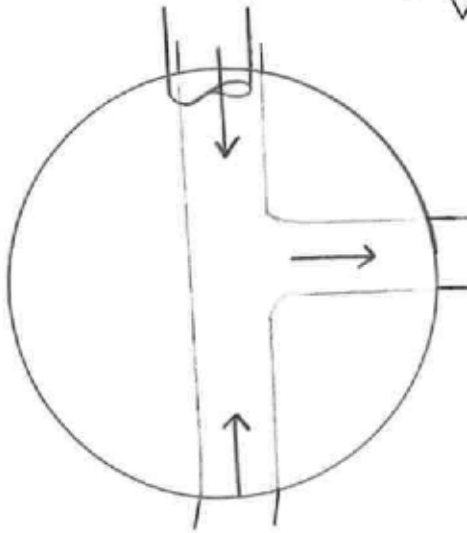
Visual Infiltration: (Y) / N

- ☐ Approx Dia. of Stream: \_\_\_\_\_
- ☐ Water flows freely but most runs down wall
- ☐ Water flows from leak in a bubbling manner and runs down wall
- ☒ Water flows from leak and runs down wall

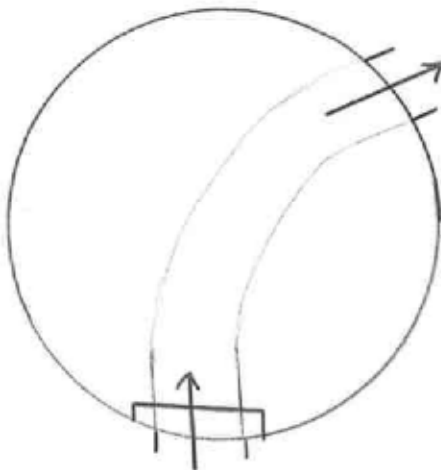
Visual Infiltration: (Y) N

- ☐ Approx Dia. of Stream: \_\_\_\_\_
- ☐ Water flows freely but most runs down wall
- ☐ Water flows from leak in a bubbling manner and runs down wall
- ☒ Water flows from leak and runs down wall

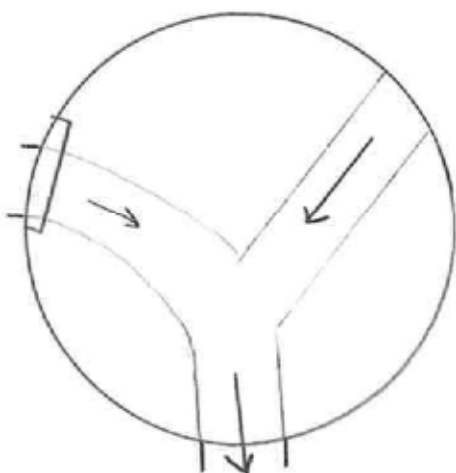
- ☐ Approx Dia. of Stream: \_\_\_\_\_
- ☐ Water flows freely but most runs down wall
- ☐ Water flows from leak in a bubbling manner and runs down wall
- ☒ Water flows from leak and runs down wall  
Between top and middle section

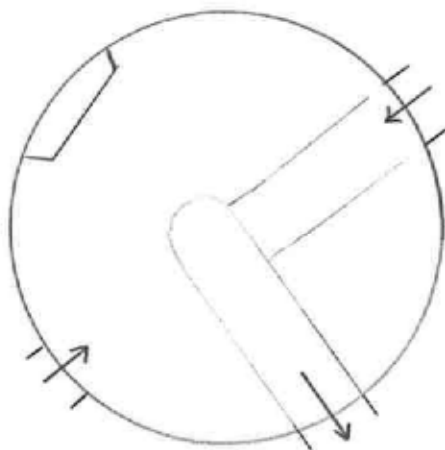
Picture #'s 290 (open) - 297
**Plan View**

Visual Infiltration: (Y) / N

- ☐ Approx Dia. of Stream: \_\_\_\_\_
- ☐ Water flows freely but most runs down wall
- ☐ Water flows from leak in a bubbling manner and runs down wall
- ☒ Water flows from leak and runs down wall
